# **PRESERVATION ASSESSMENT AND TREATMENT PROPOSALS FOR THE CAPTAIN TED CONAWAY MEMORIAL NAVAL CEMETERY, NAVAL MEDICAL CENTER PORTSMOUTH, PORTSMOUTH, VIRGINIA**

October 23, 2006 Final

**Chicora Research Contribution 450**

**Prepared for Naval Facilities Engineering Command**

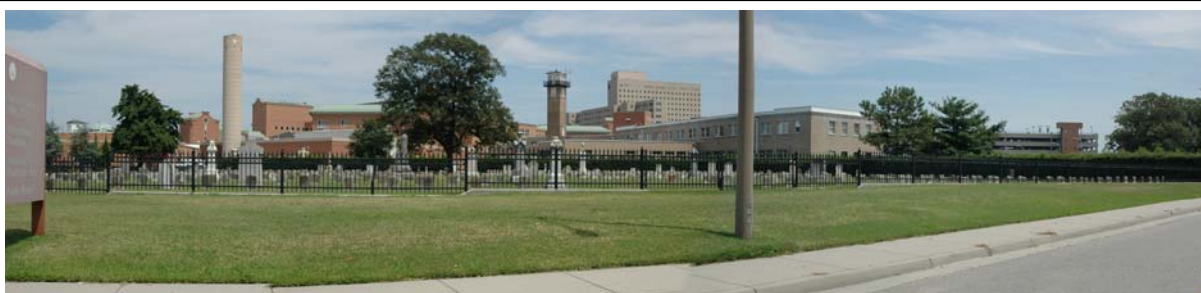
Figure 6. Panoramic view of the cemetery along Gendreau Road showing a variety of the intrusive elements.

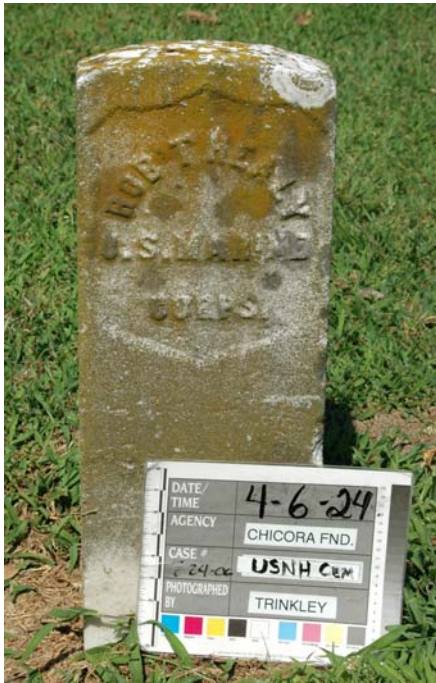
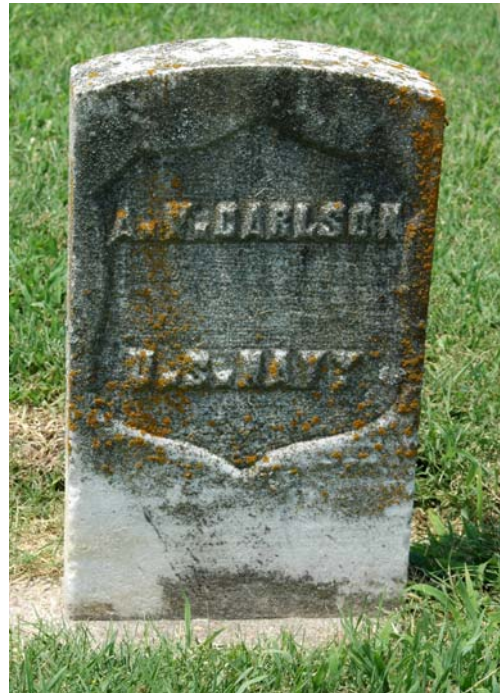
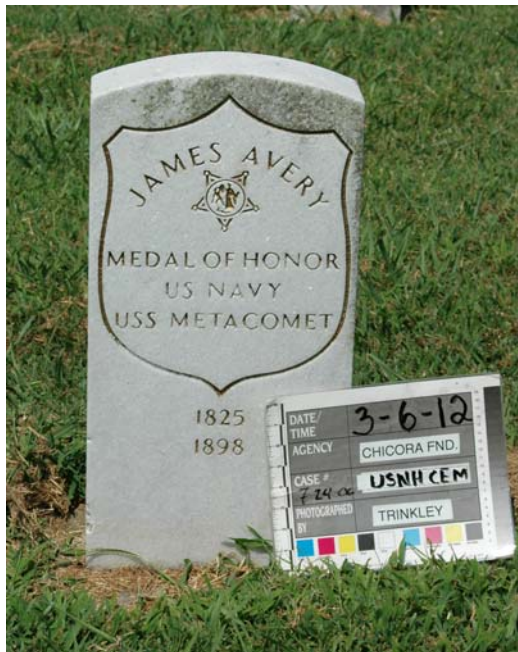
Figure 7. Examples of extant government stones. A, original 1873-1902 10-inch wide "Civil War" stone; B, 1903-ca. 1920 12-inch wide "Civil War" stone; C, modern replacement of "Civil War" stone showing deviation from the historic fabric and character; D, "General Issue" stone that is set too low, detracting from its design and historic character.

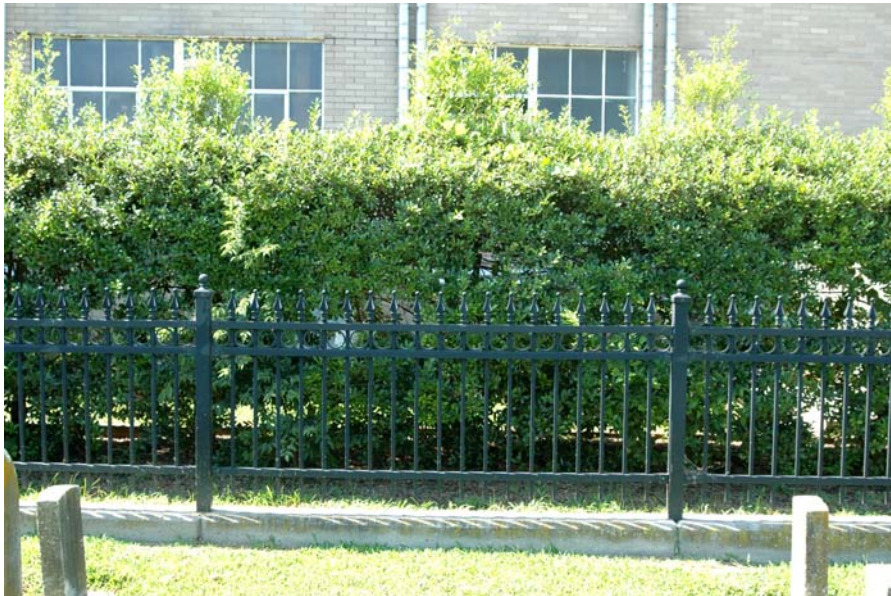
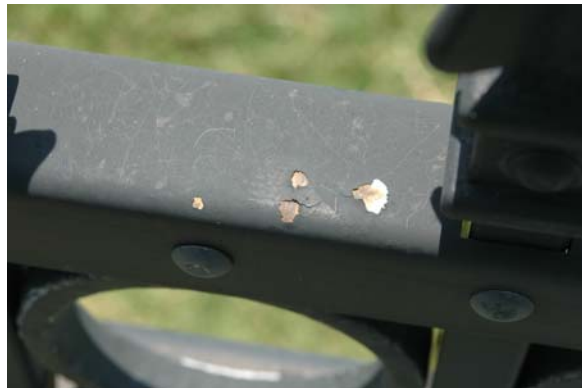
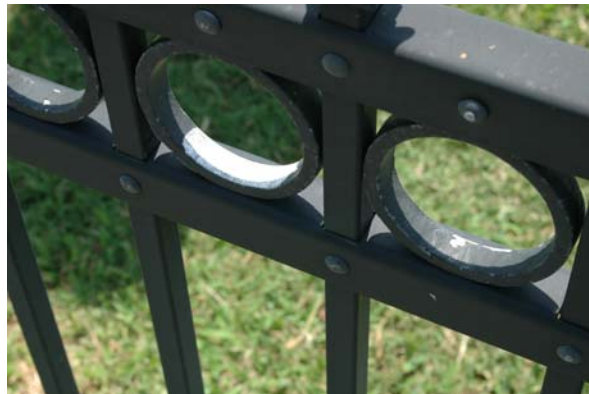
There is also evidence of missing elements (such as chain and chain weights), as well as damaged or missing retaining rings originally set in the granite posts with lead. Most troubling, however, is the evidence of very poorly performed repairs using inappropriate materials and techniques. It is critical that only trained conservators perform repairs and treatments of the historic fabric.

Figure 11. Modern boundary fence. The top photograph shows the heavy, out of scale appearance of the fence. The lower photographs illustrate paint dulling, chips with underlying corrosion, and flaking from galvanized trim. Note also the abundant use of rivets that detracts from the overall appearance.

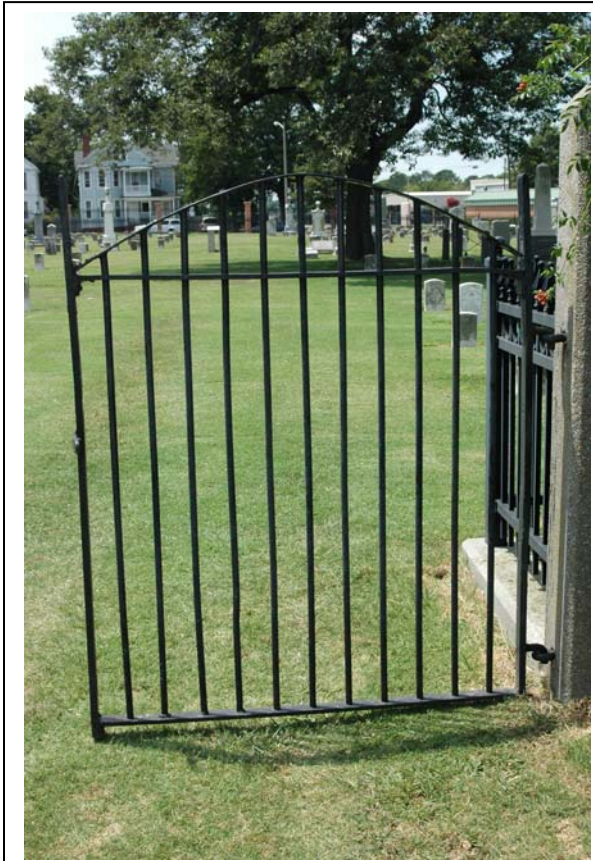
Figure 12. Heavily modified gate at the east entrance to the cemetery.

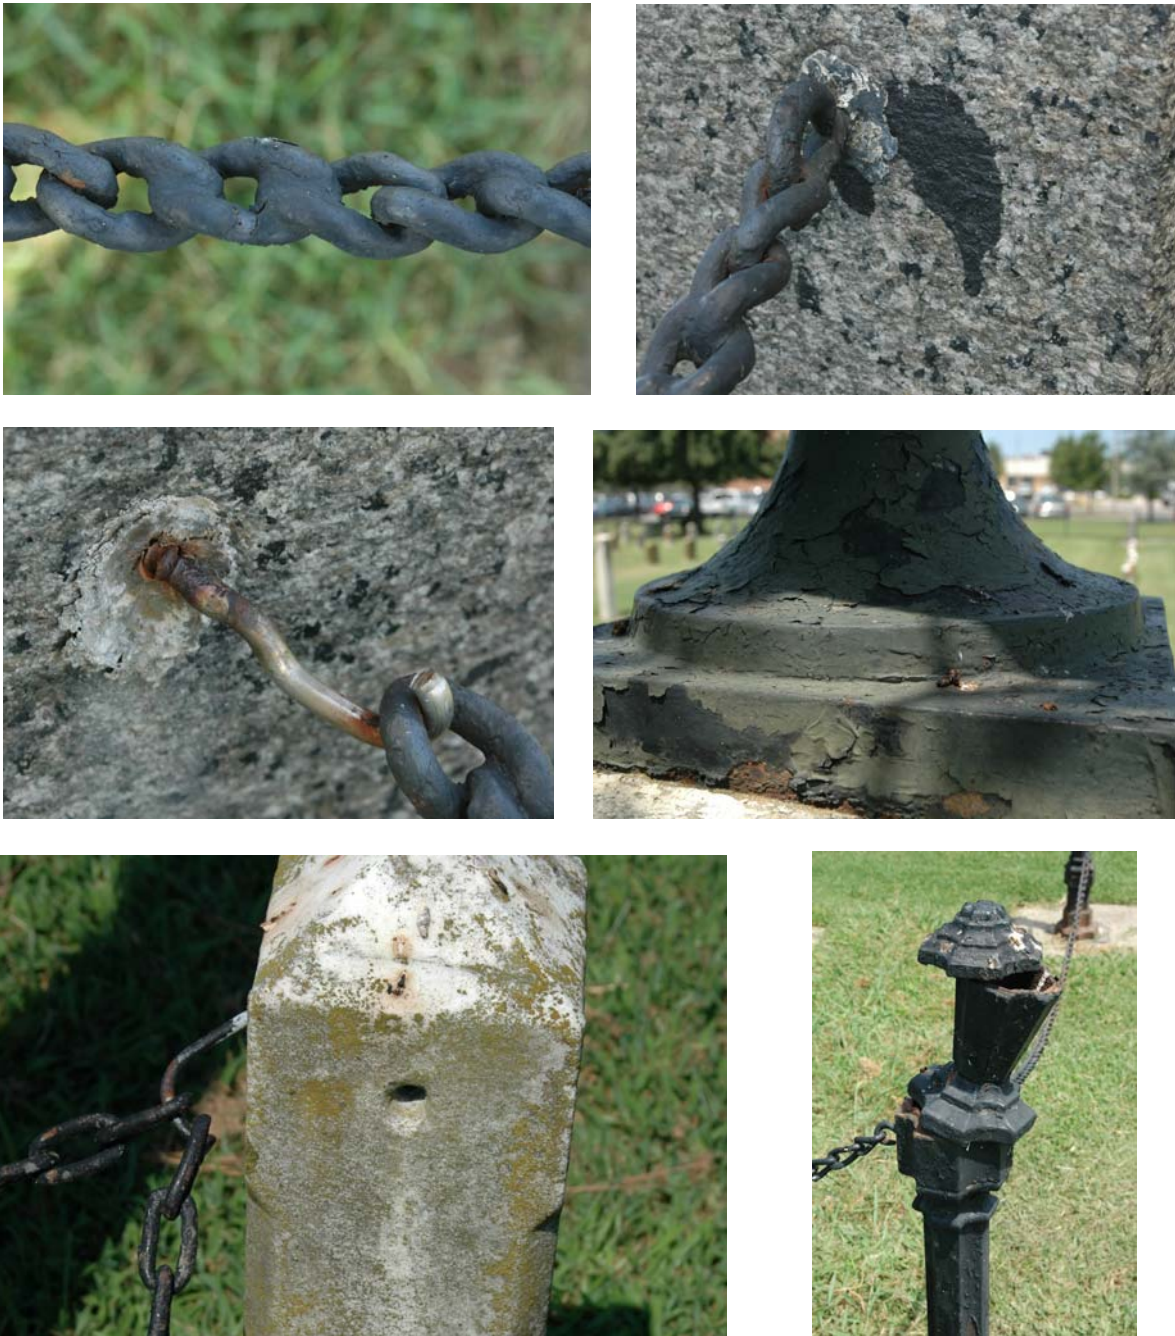
Figure 13. Extensive problems with historic fencing and monuments in the cemetery. Upper left, paint so heavily applied that details are obscured and the chain links are bonded; upper right, paint applied to the stone; middle left, inappropriate repair; middle right, heavy paint flaking and corrosion on the urn; lower left, missing and damaged connectors; lower right, heavily damaged fence post showing corrosion resulting from water penetration.

This maintenance program will significantly improve the appearance of the ironwork in the cemetery and will help prevent additional corrosion and deterioration of the various fence components.

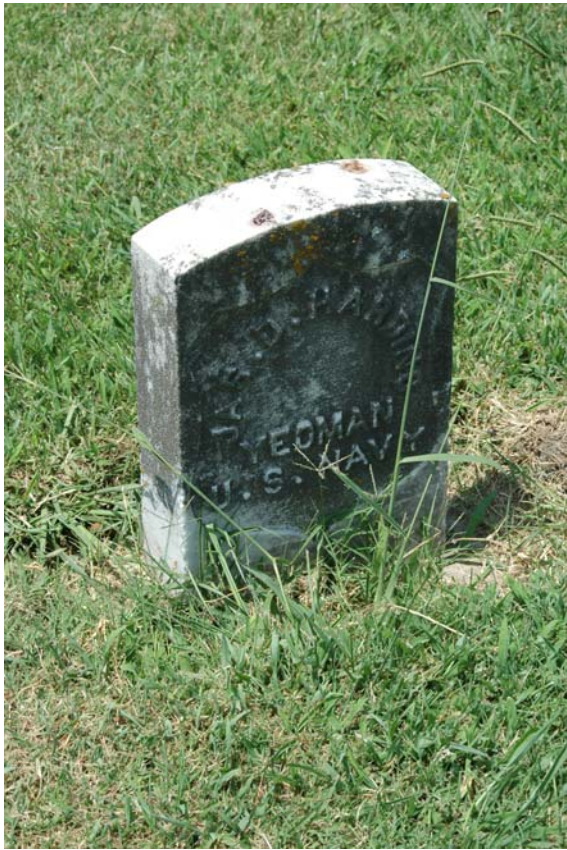
Figure 14. Typical unsightly seed head production of bermudagrass.

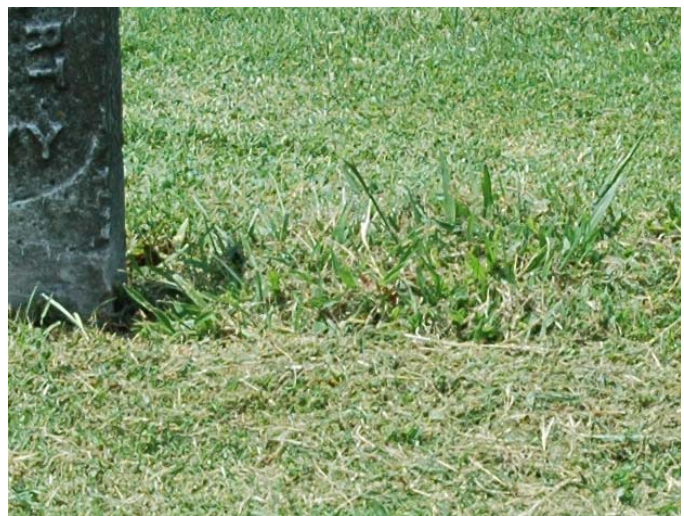
Figure 15. Excessive growing height, with removal of nearly two-thirds of the tissue.

was being delayed until the grass was over 2-inches in height and was being cut back to  $\frac{3}{4}$ -inch (Figure 15). Allowing the grass to grow this high produces a shaggy, unkempt appearance, while reducing its height by nearly two-thirds dramatically stresses the grass.

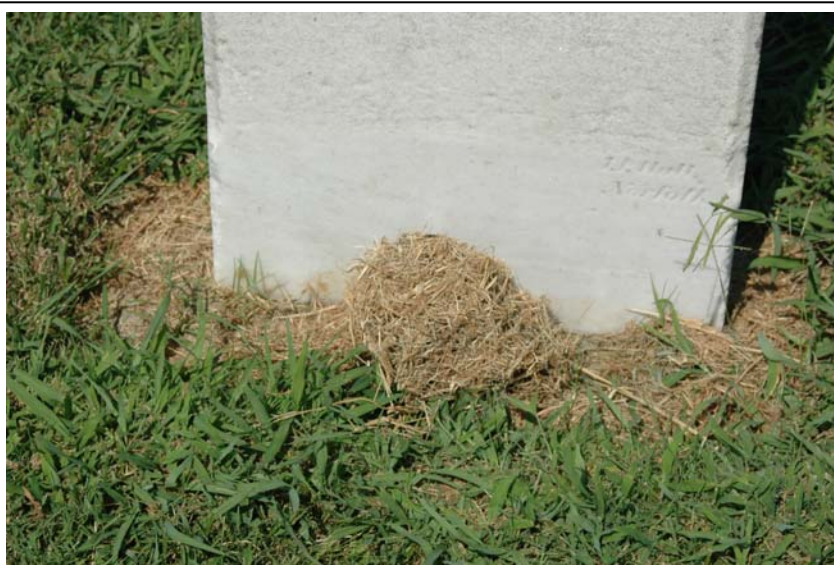
Figure 16. Grass clippings built up on stones in the cemetery.

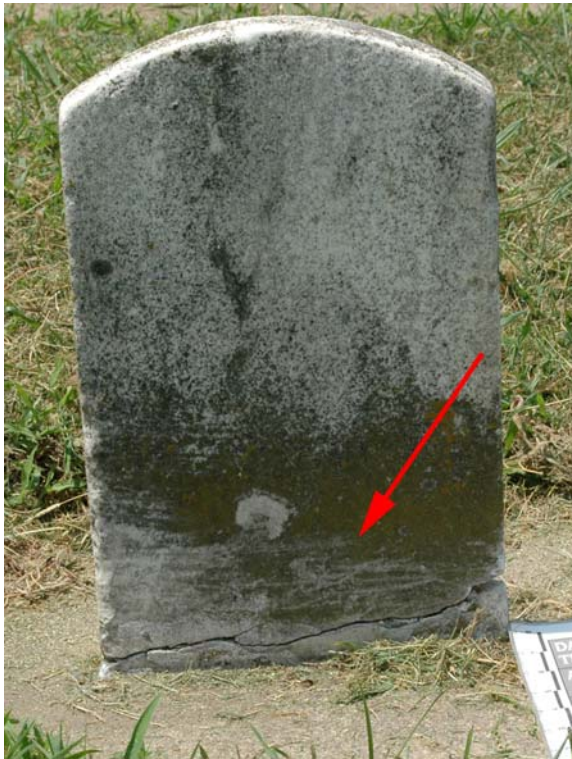
Figure 18. Nylon trimmer damage.

staff since technicians will want to use a heavier line to reduce their work and speed the process. Figure 18 illustrates one stone with abundant striations typical of aggressive nylon trimmer damage.

present as discards in the cemetery. We recommend that no line heavier than .065, or at most .095-inch, be allowed in the cemetery. This will require careful attention of the supervisory

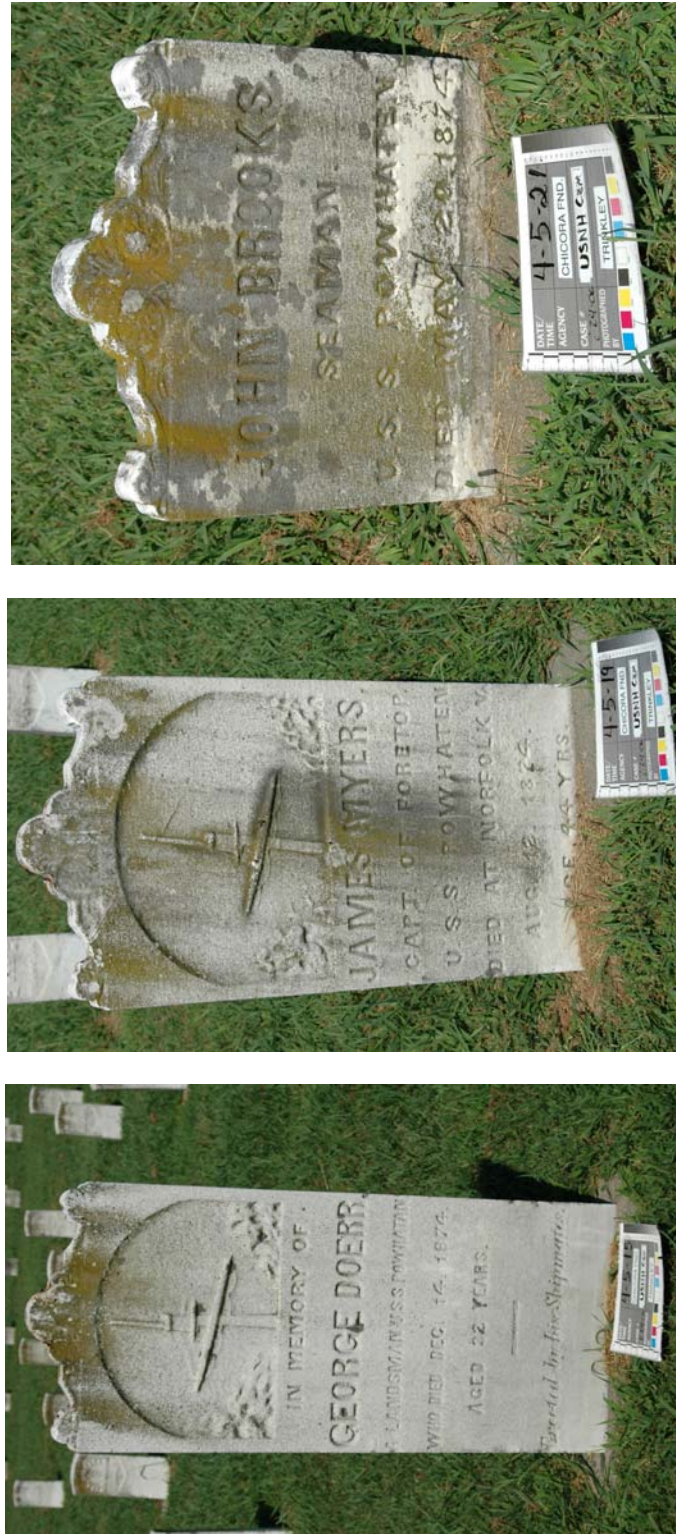
Figure 20. Comparison of three very similar stones showing extreme differences in setting heights, ranging from 48-inches (far left) to 39-inches (middle) to 19-inches (far right).

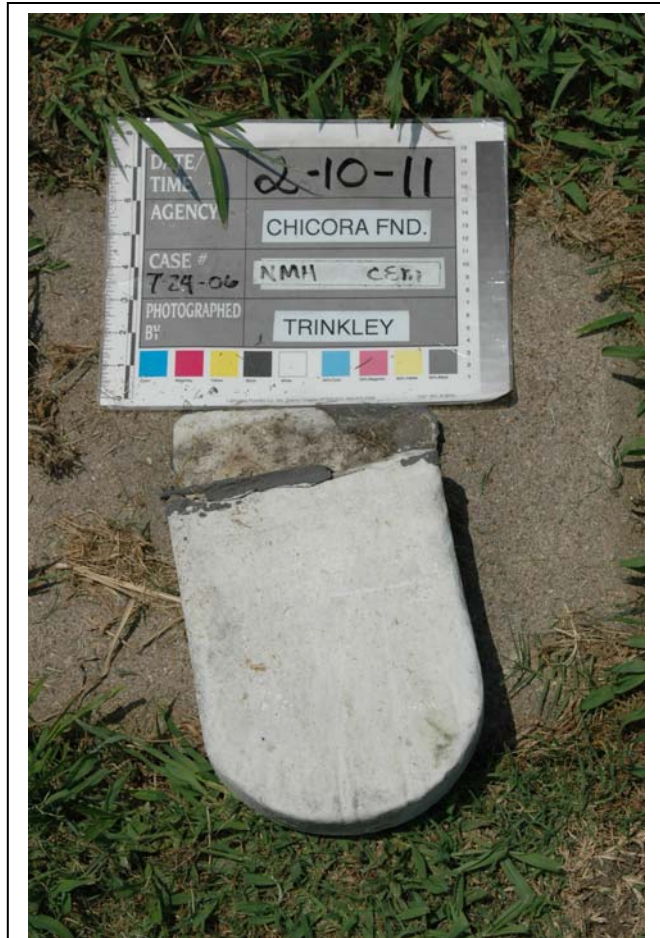
In several other cases we observed stones where repairs had been made using a white Portland cement. Unfortunately this material is entirely too hard for marble. In addition, the repair material has been applied so thickly and poorly that it has defaced the marker, making future repair far more difficult and costly.

Figure 22. Inappropriate epoxy-like repair that has failed.

There is no single specification for the repair of marble or sandstone, but in general we can caution the Navy that modern monument dealers (and the general public) are unfamiliar with historic stone and have little or no appropriate experience in its care and repair. When repairs of old stones are needed, only a stone conservator who subscribes to the

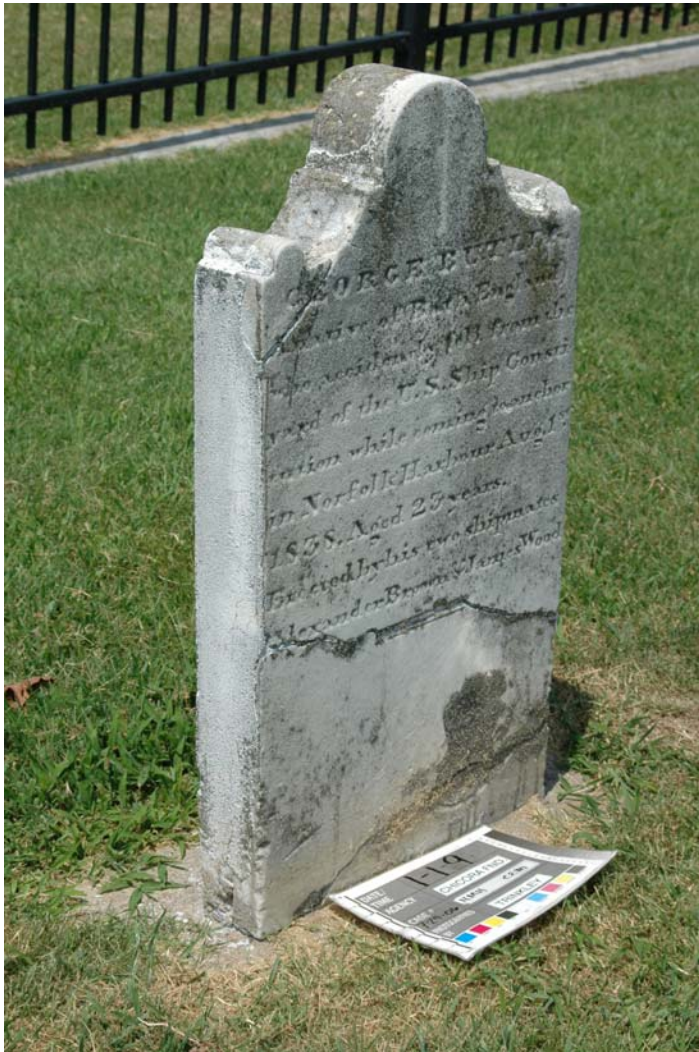
Figure 23. Use of white Portland cement to reinforce a monument, dramatically increasing its thickness and changing its overall character.

Standards of Practice and Code of Ethics of the American Institute for Conservation of Historic and Artistic Works (AIC) should be retained.
